## ANALYSIS AND STUDY OF SETTLEMENT OF SOME BUILDINGS IN ADEN - A CASE STUDY

Dr. Faisal Shamsheer

Asst. prof. Faculty of Engineering, Aden University, YEMEN

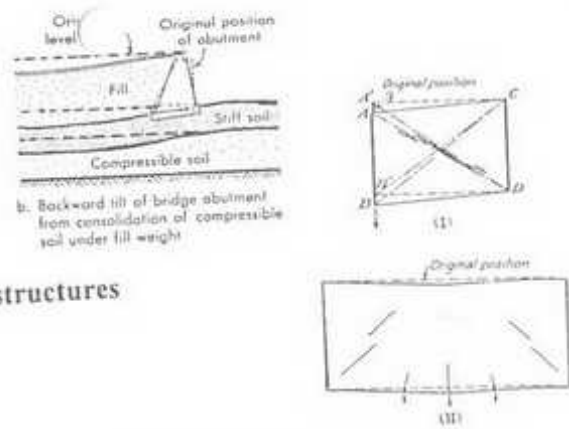
Fig.6 Inclination Cracks in Walls

**Differential Settlement :** The inclination of cracks provides clues regarding the differential settlement which produced them as shown in Fig. 6I indicate that the wall AB must have moved downward in respect to CD from its original position A'B'. This elongated the diagonal CB' to CB produced tension in the direction of that diagonal and formed the cracks. The same effect could be obtained if the wall A'B' stayed in its original position and the wall CD moved upward, because dry clay beneath the foundation swelled most under the corner during a rainy season and lifted it (9). Similarly, the pattern of cracks shown in Fig. 6II can be produced either by the greater

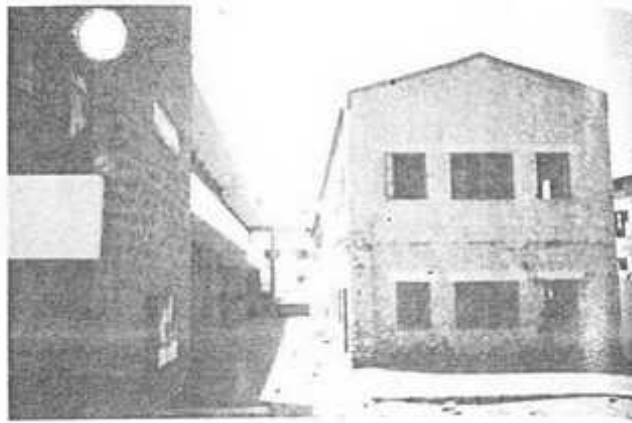
Plate 3 View of the two Buildings

**Computation:** The settlement of this ( ) was calculated the effect of the weight of the surrounding building constructed in 1980 at a distance of 7.2m from the existing old one plate3. This study may or may not proved whether the weight of the new building causes the settlement of the old building. The additional pressure or stress increment calculated by using superimposed Fadum method (10) for computing stress distribution in the soil for points P and Q as shown in Fig.9. Settlement calculation was done by the equation ( $s = mv.H \Delta \sigma$ ) at points P and Q, the settlement calculations at these points are  $S_P = 3mm$  and  $S_Q = 30 mm$  respectively. Therefor the differential settlement equals to 27mm

**Discussion:** Based on the computation of the settlement and observation of the cracks it may be reveal that the differential settlement was occurred but it is relatively small. The construction of the new existing building in (1980) may help to increase the cracks due to differential settlement (27mm) and the cracks also may be due to the oldest of this building. In this case there is no effect of ground water table.

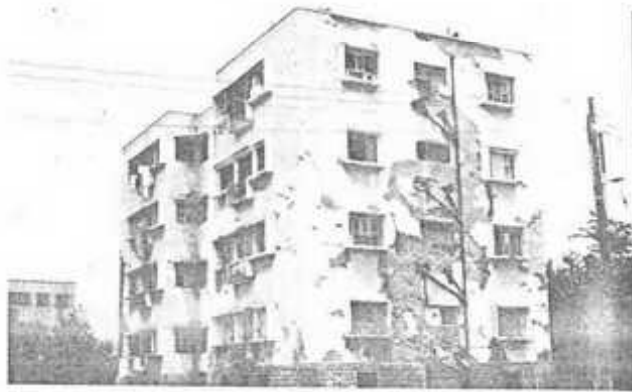
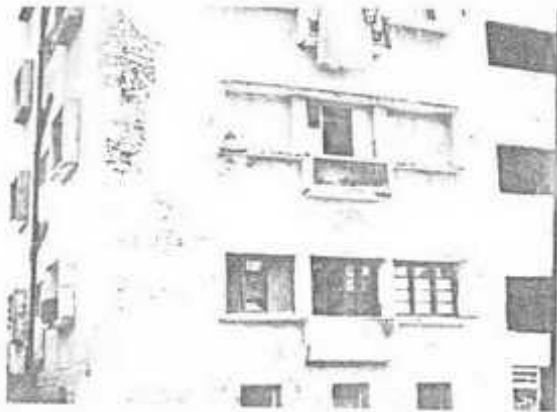
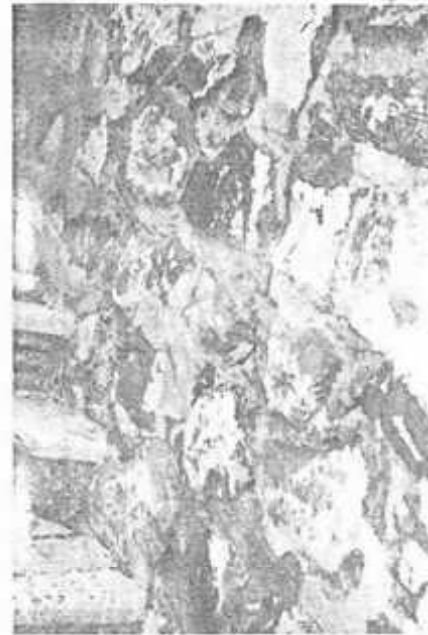
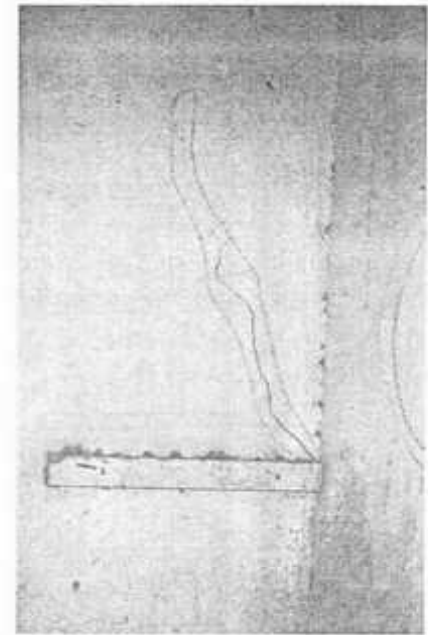
Plate 2 Different Types of Cracks

**Description of Cracks:** The cracks appear in this building are vertical, horizontal and diagonal, some of these cracks are of dangerous type as they are relatively wide. These cracks are clearly shown in plate 2.

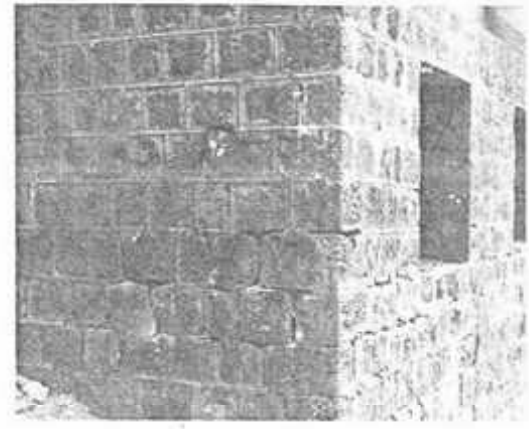
Plate 5 Vertical Cracks

**Description of Cracks:** In the present case study the cracks are take place in vertical, diagonal positions and appear in different sides of the building (plate4). Diagonal cracks are observed in the corner of the building which is started from the edge and continue as shown in plate4. The vertical cracks are observed in the entrance of the building column (only one column) and load bearing wall as shown in plate 5. From plate 5 it can be seen that the vertical crack appears on the walls and meet feiw horizontal cracks which causes the separation of stone.

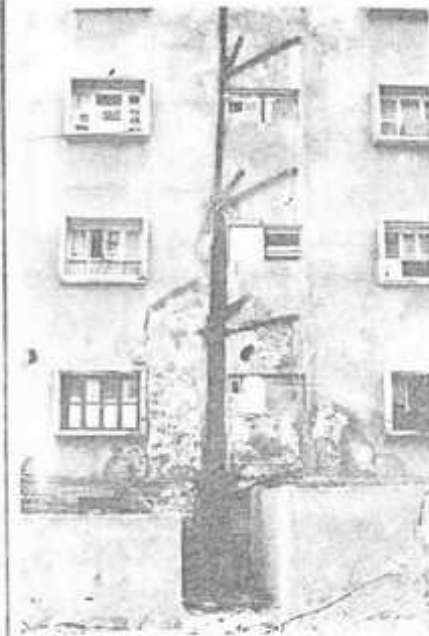
Plate 6 Leakage of Sewage Pipe

**Discussion:** In the present case there is more than one reason causes settlement, the computational results obtained that the immediate settlement of 60mm which is normally undergo this type of settlement. But due to the present of silty particles made the consolidation settlement calculation is necessary. The calculation of consolidation settlement observed at the center and corner is 150mm and 18mm respectively. The difference between these two values gives differential settlement that occurs between corner and center. Furthermore it can be observed that there are other reasons as: (1) The leakage of sewage pipes as shown in plate 6, results in saturated the loose sand, (2) The present of water table at shallow depth. (3) The oldness of the building, (4) No regular maintenance and (5) No care from the residents.

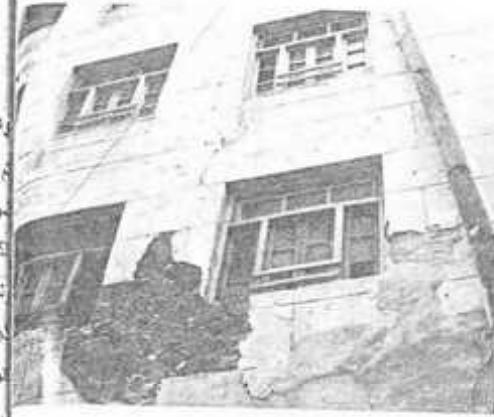
Plate 9 Diagonal Cracks

**Description of Cracks:** The cracks are vertical and diagonal have been observed (plate9) which are symmetrical cracks on the corners of the front elevation. In the one of the back elevation there is a huge failure of the corner started from the top and extended across all the stories as shown in plate 10.
