SETTLEMENT EVALUATION OF POMISE MOSQUE AT ADEN - A CASE STUDY

Abstract: The present paper discusses the case study of a mosque that occupied an area of 622m² and consisted of a single story. During the use of the mosque for 18 years, cracks took place as minor then widened and increased, excessive settlement took place. In 1998 the mosque was demolished and reconstruction carried out. An attempt has been made to study and analyze this case in depth. The study is based on 1. Observation of the cracks, 2. Site investigation and 3. Study the design of the demolished mosque. The cracks appeared as horizontal, diagonal and of dangerous types. For soil investigation, three-bore holes were made up to a depth of 3.25m in the site of the demolished mosque. The site was on a slope. The evaluation and study of the case found that the design of the foundation was inadequate bearing on wall acting as a retaining wall up to a depth of 2.4m to be level with other footings. The analysis of the retaining wall shows that the factor of safety against overturning and sliding is less than one.

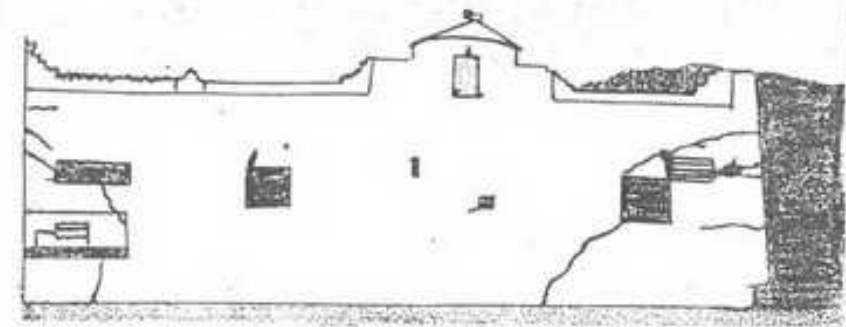
In the present case study, the cracks are concentrated in the corner of the mosque of diagonal types as shown in Plate 1. Cracks were also observed near the openings (windows/doors) at the top and at the bottom as illustrated in Plate 2. These cracks started as minor then widened at the end. Horizontal cracks were observed in the load - bearing walls at the top of the walls (Plate 3). Random cracks were also observed in different places of the partition walls. The study of the types of cracks reveals the following:

- 1- Diagonal cracks (Plate 1), observed in load bearing walls, might be due to differential settlement and shear failure (Shamsheer, 1998).
- 2- Corner and angular cracks (Plate 2) developed due to mistake in design (Al – Issa, 1998). The cracks observed in windows/doors (Plate 2) might be due to poor materials / construction (Mustafa and Shonoda, 1996).
- 3- Horizontal cracks as shown in the corner of the mosque (Plate 1 and 3) may be due to poor materials used, and discontinuity of the construction.

Plate 1 : Diagonal Cracks at corner

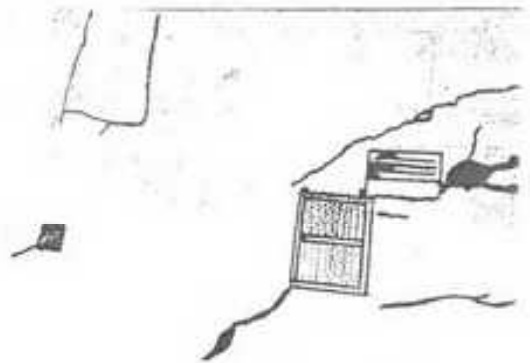
Plate 2 : Cracks at the Openings

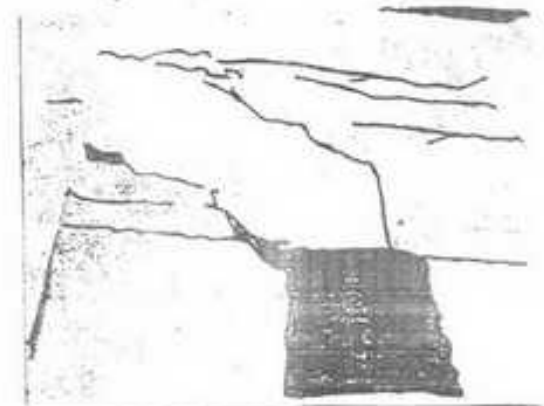
Plate 3 : Horizontal Cracks

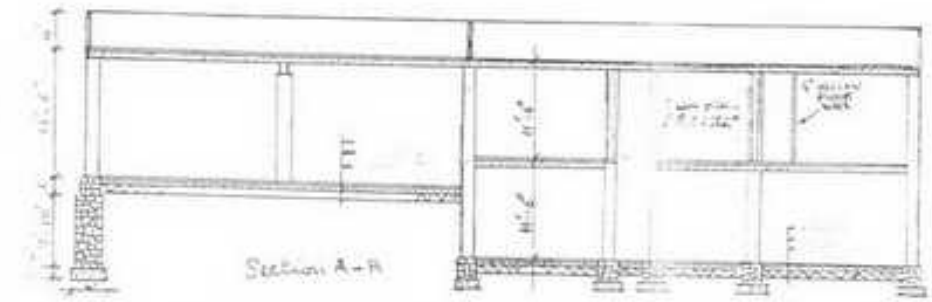
Fig.7 Footings and Wall Foundation (Retaining Wall)

2. **Bearing Capacity:** the site is of slope nature with an angle $w = 6$ which has an influence in the computation of the bearing capacity. Referring to the design of footing (Fig.7), the width of the strip footing is $B = 1.2m$ with an average depth of $D = 0.9m$. Based on the results of soil testing and site investigation of upper layer, the soil is poorly - graded gravelly sand (GP), having internal friction angle $\phi = 30$ $14.0kN/m^3$ (Fig.5). To compute the ultimate bearing capacity (q_{ult}) of strip footing founded on the face of slope Meyerhof's (1957) equation is adopted: $q_{ult} = 0.5$ where N is bearing capacity factor depending on D/B ratio, ϕ and w , obtained from chart given by Meyerhof. The ultimate bearing capacity is found equal to $420kN/m^2$. The back calculation of the design load, including the dead load of the masonry wall transmitted to the strip footing, gives $P = 500kN/m$. Then the actual pressure on the soil

due to the weight of structure $q = 500/1.2 * 1 = 417 \text{ kN/m}^2$. To check the factor of safety (F.S) with respect to shear failure, in terms of the net ultimate bearing capacity = $(q_{ult} - \gamma D)$ and net foundation pressure = $(q - \gamma D)$, the following equation was used to check the factor of safety: $F.S = (q_{ult} - \gamma D) / (q - \gamma D)$, the computation of the factor of safety is found $F.S = 1$. If the factor of safety is considered 3 as it is common in practice then the allowable bearing capacity $q_{all} = q_{ult} / F.S = 140 \text{ kN/m}^2$. Therefore the allowable load $P_{all} = (140 + 12.6) * 1.2 * 1 = 183 \text{ kN}$ only, where the required allowable load is 500kN. This indicated that shear failure has occurred to the base of the footing which confirms the cracks observed in the corners.

3. **Retaining wall:** as it is mentioned before the site is on a slope with angle $\beta = 6^\circ$, the foundation supports a retaining wall of 0.9m thick masonry stone up to a depth of 2.4m to be level with other footings Fig 7. The length of the wall is found 28m, carrying a load of 500 kN/m transmitted to the width of the retaining wall 0.9m, the surcharge $q = 500 / 0.9 * 28 = 20 \text{ kN/m}^2$ is considered. The final distribution of loads on the retaining wall is illustrated in Fig 8. No shear stresses act on this vertical wall, therefore the Rankine theory is used to calculate the active and passive pressures. For passive resistance calculation Tomlinson (1986) procedure was adopted. The pressure distribution is shown in Fig 9. The unit weight of masonry stone and concrete base are taken to be 20 kN/m^3 and 23 kN/m^3 respectively. The active and passive pressures are calculated on the vertical through the toe of the wall given in Table 1. The total active and passive forces are calculated from the numbered triangles and rectangles as cited in Fig 9 and presented in Table 2. To determine the position of the base reaction, the moments of all forces about the toe of the wall (x) are calculated and given in Table 3.

From the above it can be found that the base pressure at the toe of the wall exceeded the allowable bearing capacity of the soil (100 kN/m²). The presence of the tensile pressure at the base is not allowed because the tensile pressure of the soil is very small, so R.C.C. base is used.

The values of the safety factor against sliding and against overturning, the minimum value at the least 1.5 usually being specified, in the present study both values are less than one, which indicated that the overall stability of the retaining wall is not calculated and checked by the designer.
