## ANALYSIS AND STUDY OF SETTLEMENT OF SOME BUILDINGS IN ADEN - A CASE STUDY

Dr. Faisal Shamsheer

Asst. prof. Faculty of Engineering, Aden University, YEMEN

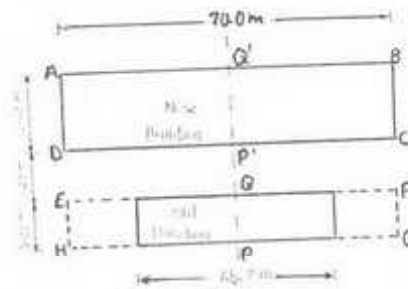
Fig.9 Plan of Two Buildings, Case 1

**Discussion:** The differential settlement obtained from the calculation of these case study which is found to be too large which may be due to the nearer end to the new building (right to the existing building) settled 370mm whereas the far end did undergo any settlement (left to the existing one) which is causes a failure damage as shown in plate 10. This is may be a reason of the differential settlement. But there are may be other reasons developed the increase of the differential settlement which are: (1) The oldness of the building, (2) the soil beneath the foundation, (3) the sewage condition is not maintained (plate.11) which may cause in saturation of the soil beneath the foundation and, (4) The excavation of the basement near the old building without any soil protection (in the left side plate7b) which may develop the further damage to the building especially that the settlement has already taken place after completion of right side new existing building.

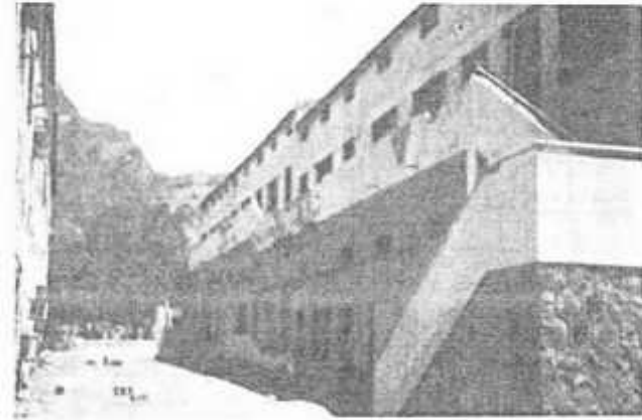
Plate 1 View of Building and No. of Storeies , Case 1

The case study was, of one building from Technical Institute, located in Maalla town in Aden city. The site plan given in Fig.7. This building constructed nearly in cities as a class rooms for teaching purposes, occupied an area of 48.35m x 8.35m as shown in plate 1. The building consists of two stories with asbestos covered ciling, the walls constructed of masonry stone of 40cm thick, the first floor made of timber joists and a timber boarding covered by plain concrete of thickness 10cm. The foundation type is strip footing with a width of 1.6m and depth of 1.8m, the base of footing is of plain concrete slab with depth of 60cm as shown in Fig.8. The soil investigation in the vicinity reveal that the subsoil below the footings was a compacted mixture of medium sized gravel with sand and silt. The vicinity surrounding by a volcanic mountains as the west bed is rock strata as shown in Fig.8.
