SETTLEMENT EVALUATION OF POMISE MOSQUE AT ADEN - A CASE STUDY

Abstract: The present paper discusses the case study of a mosque that occupied an area of 622m² and consisted of a single story. During the use of the mosque for 18 years, cracks took place as minor then widened and increased, excessive settlement took place. In 1998 the mosque was demolished and reconstruction carried out. An attempt has been made to study and analyze this case in depth. The study is based on 1. Observation of the cracks, 2. Site investigation and 3. Study the design of the demolished mosque. The cracks appeared as horizontal, diagonal and of dangerous types. For soil investigation, three-bore holes were made up to a depth of 3.25m in the site of the demolished mosque. The site was on a slope. The evaluation and study of the case found that the design of the foundation was inadequate bearing on wall acting as a retaining wall up to a depth of 2.4m to be level with other footings. The analysis of the retaining wall shows that the factor of safety against overturning and sliding is less than one.

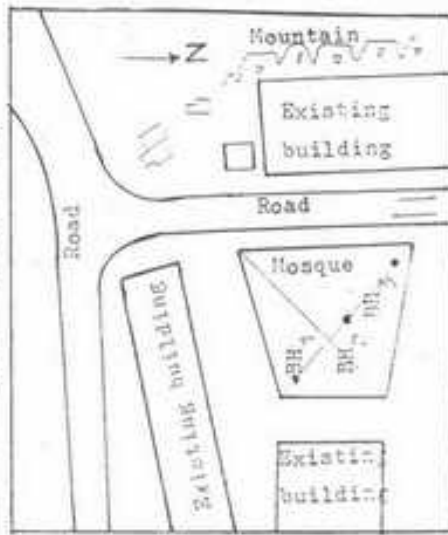
Fig.2 Site plan of Pomise Mosque

The general locality of the mosque is in the southern part of Al –Taweela region in Aden City known Al-Zariba; this region is an extension of mountain series of Shamsan Mountain with a valley as shown in Fig.1, this place is a pumice volcanic environment. The mosque is located in the Al-Taweela yard far around 150m from the valley. The site plan of the mosque is given in Fig.2. The pumice mosque was built in 1972, but due to shortage of fund the construction was stopped, then the construction has been started and completed in 1979. The mosque occupied an area of 622m² and consisted of single story with attached tow story building (school and Imam house). In 1998 the mosque was demolished due to series of dangerous cracks that appeared in the walls and floors, in general in all the structure. Before starting the construction of the new mosque, three trial pit bore holes (BH) up to a depth of 3.25m have been conducted. The location of these BH is shown in Fig 2. From each BH disturbed samples have been collected and tested in the Soil Mechanics Laboratory of Civil Engg. Dept., Faculty of Engineering. The test results and soil profiles of the 3BH of the site are illustrated in Fig.3. It can be found that there are four layers. The upper layer of thickness 1.0–1.4m of gravelly sand, second layer of 0.15– 0.25m as a pocket of sandy gravel, the thickness of the third layer is 0.75–1.10m of gravelly sand and the last layer ranges from 0.95–1.12m of gravelly sand. It can be said that the soil in general is gravelly sand except the pocket of sandy gravel. The results of the grain size distribution given in Fig.4, show that the soil is gravelly sand. The values of coefficients of curvature C_c and uniformity C_u are varying from 0.25–1.1 and 3.25–42.86 respectively. According to the unified soil classification system (Wagner, 1957); the soil can be classified GP, a poorly – graded gravelly sand. In the present investigation, calculation of void ratio has been made based on the values of field density obtained in the site (14kN/m³) and results of specific gravity obtained in the laboratory (2.65). The computed value of the voids ratio is found 0.893 which seems to be very high when compared with typical values given by Das, 1985.

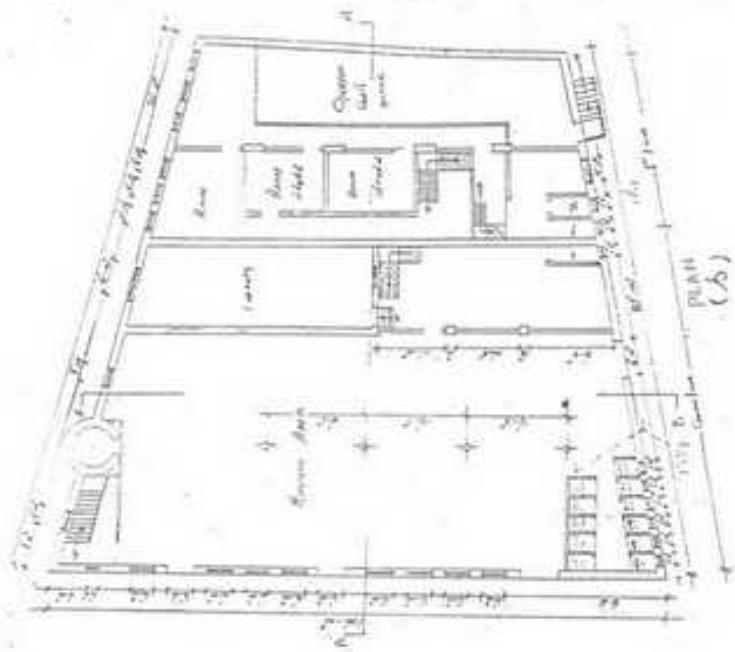
Fig.5 Plan of the Mosque with attached House.

1. **Nature of the Structure:** the mosque occupied an area of 622m² and, consisted of single story attached with big store, Imam house and Quran boys school in ground floor. In the first floor, there was a mosque terrace with library and Quran girls school as shown in Fig.5 a and b. The terrace was also used by prayers specially on Fridays. It was made of timber joists and timber boarding covered by plain concrete of thickness 10cm. It should be noted here that in the design drawing (Fig.6) it is mentioned that R.C.C slab is used but in the actual site visit it was found made of timber joists. This may be due to shortage of fund. The load was transmitted from terrace to the load bearing walls of masonry stones 40cm thick. The foundation type is strip footing with a width of 1.2m and average depth of 0.9m. The base of footing is of plain concrete slab with depth of 40cm for single and also for two story footing as illustrated in Fig.7. The nature of the site is slope with an angle of 6 – 5; that the mosque footings are based on a wall foundation as a retaining wall of 0.9m thick masonry stone wall up to a depth of 2.4m to be leveled with attached two story footing as shown in Fig.7.

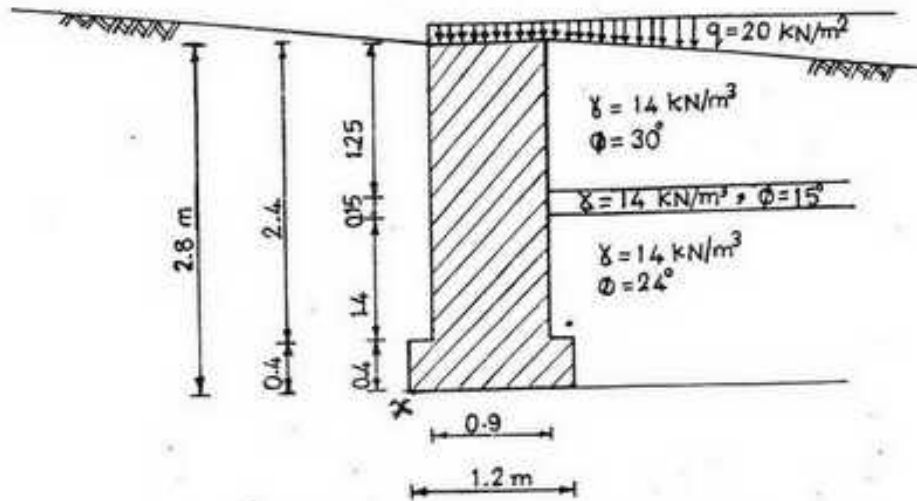
Fig.8 Distribution of Loads on the Retaining Wall .

3. **Retaining wall:** as it is mentioned before the site is on a slope with angle $\beta = 6^\circ$, the foundation supports a retaining wall of 0.9m thick masonry stone up to a depth of 2.4m to be level with other footings Fig 7. The length of the wall is found 28m, carrying a load of 500 kN/m transmitted to the width of the retaining wall 0.9m, the surcharge $q = 500 / 0.9 * 28 = 20 \text{ kN/m}^2$ is considered. The final distribution of loads on the retaining wall is illustrated in Fig 8. No shear stresses act on this vertical wall, therefore the Rankine theory is used to calculate the active and passive pressures. For passive resistance calculation Tomlinson (1986) procedure was adopted. The pressure distribution is shown in Fig 9. The unit weight of masonry stone and concrete base are taken to be 20 kN/m^3 and 23 kN/m^3 respectively. The active and passive pressures are calculated on the vertical through the toe of the wall given in Table 1. The total active and passive forces are calculated from the numbered triangles and rectangles as cited in Fig 9 and presented in Table 2. To determine the position of the base reaction, the moments of all forces about the toe of the wall (x) are calculated and given in Table 3.

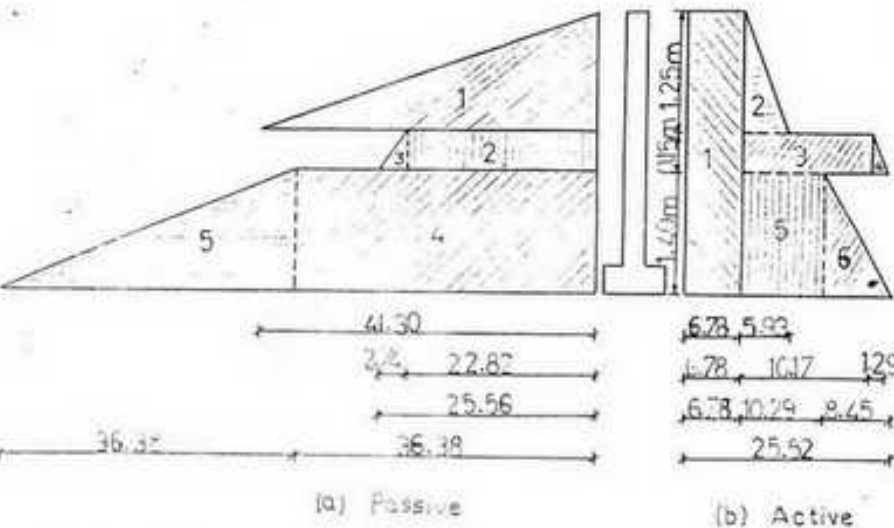
Fig.9 Pressure Distribution .

From the above it can be found that the base pressure at the toe of the wall exceeded the allowable bearing capacity of the soil (100 kN/m²). The presence of the tensile pressure at the base is not allowed because the tensile pressure of the soil is very small, so R.C.C. base is used.
